FIGHTING VEHICLES
RESEARCH & DEVELOPMENT
ESTABLISHMENT

BELLY ATTACK BY ANTI-TANK MINES Mk 7
AGAINST
CENTURION TANK TARGETS.

PROJECT NO: G1/F/311

REPORT NO: TR.57

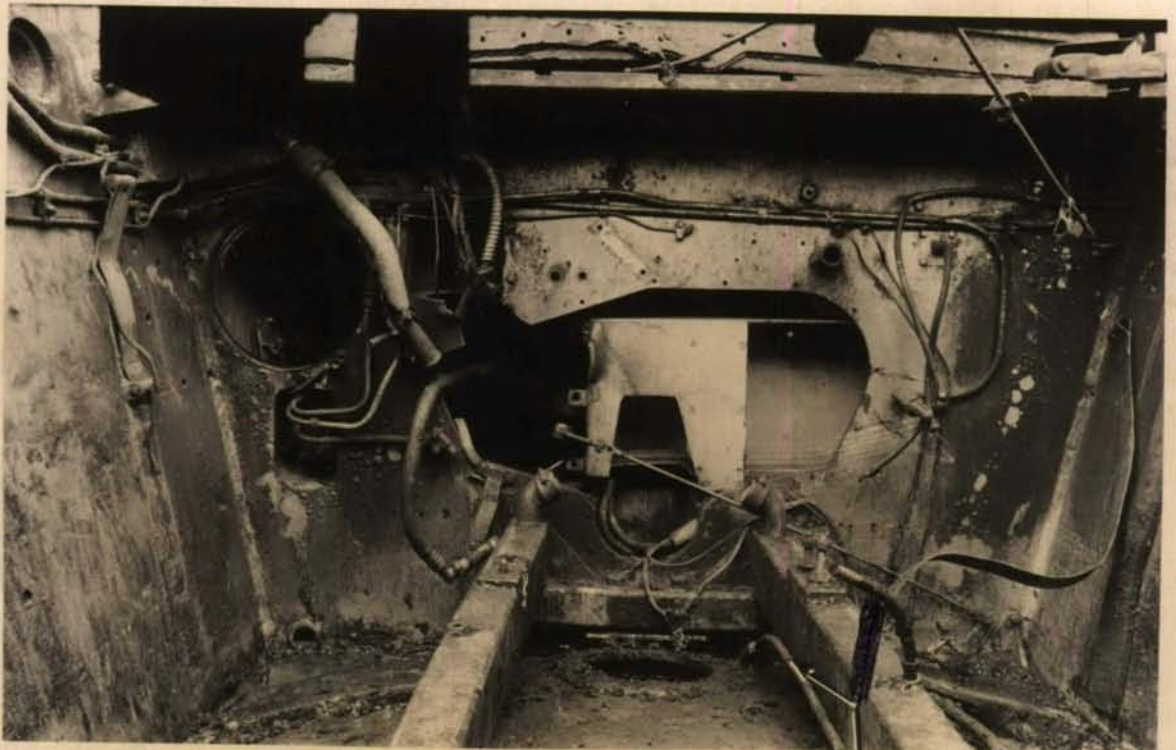
FIG. NO.3.

- I, J & K Clutch, Steering and Gear Change control rods severely bent and put out of adjustment. Right and Left steering rod bell-cranks on gearbox fractured.

ATTACK M2. ENGINE COMPARTMENT AFTER ATTACK
WITH INTERNAL COMPONENTS REMOVED SHOWING FLOOR
DISPLACEMENT AND DISTORTED CONTROL RODS.

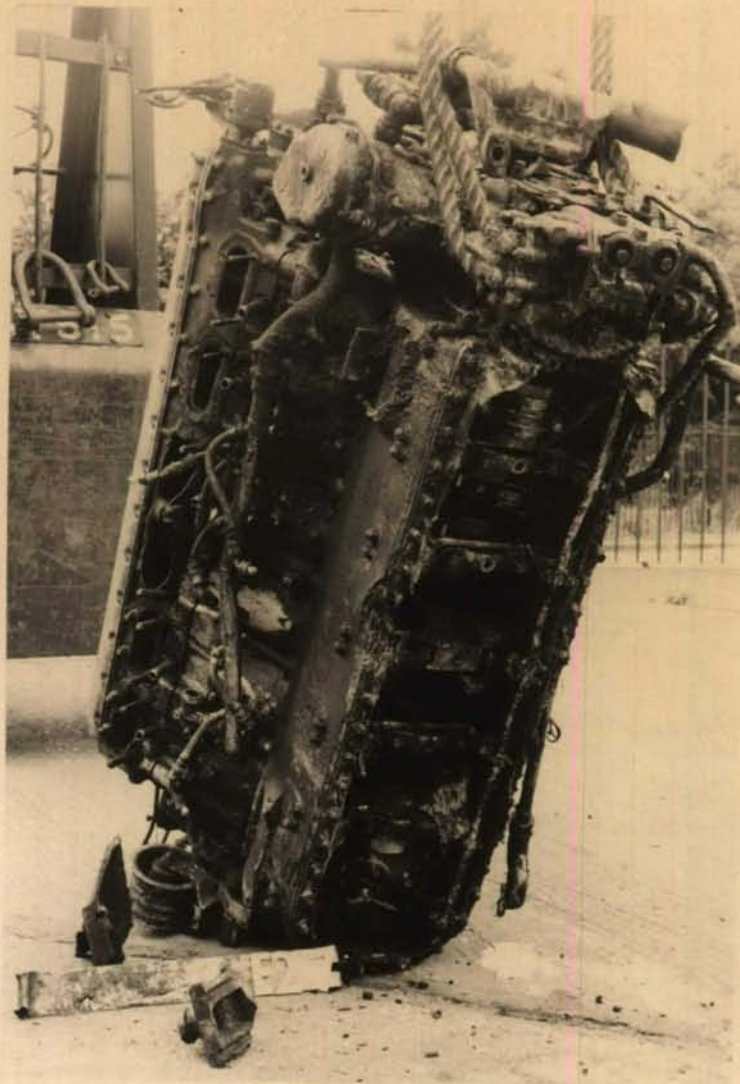
FIG. NO.4.

- E5 Engine sump shattered.
- E6 Engine crankcase sump face crushed and sides cracked.
- E7 & E8 Exhaust manifolds fractured and cylinder head fixtures damaged.

ATTACK M2. SHOWING CONDITION OF CRANKCASE
AND SUMP AS FOUND WHEN ENGINE WAS REMOVED.

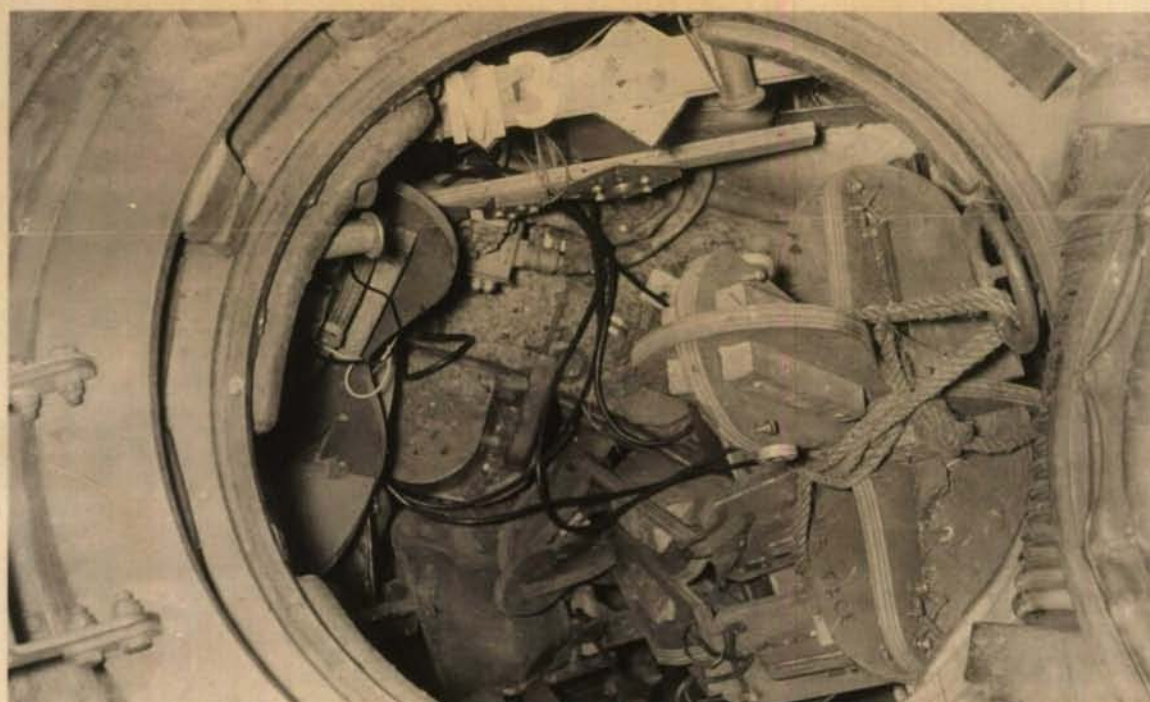
FIG. NO.10.

VIEW THROUGH COMMANDER'S HATCH AFTER ATTACK.

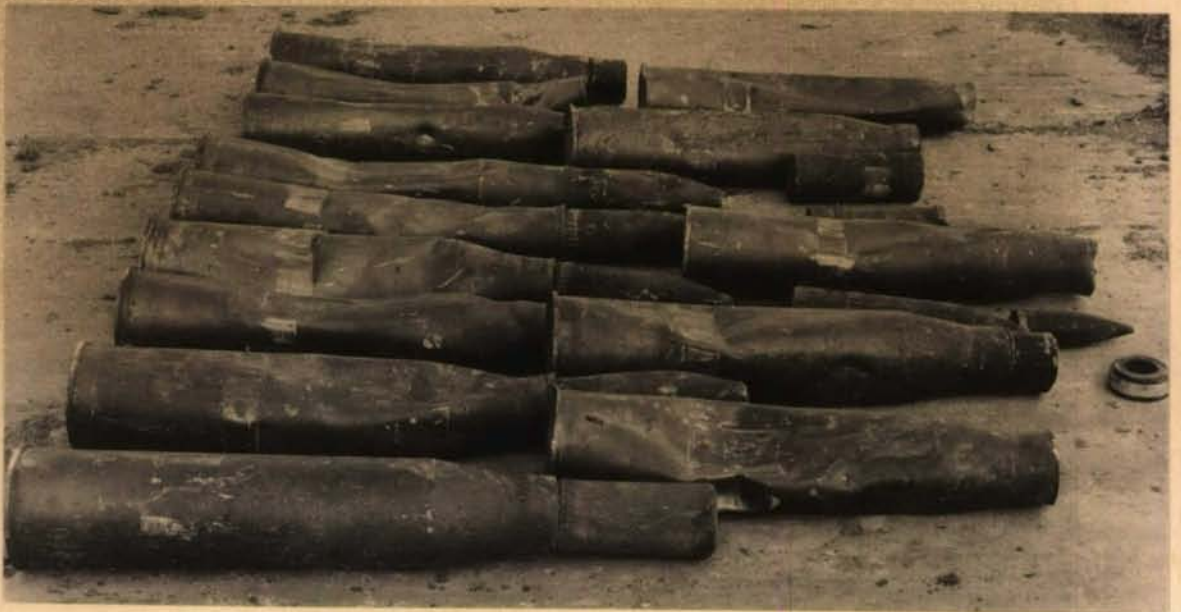
FIG. NO.14.

Ammunition stowed in the floor bins was unfit for firing, all the cartridge cases being squashed to a varying degree. Several rounds were recovered loose in the fighting compartment having been projected out of the bins. Floor bin flaps and other components were wrenched from their hinges and fixtures; the batteries were shattered and pieces scattered over the whole compartment.

ATTACK M3.SHOWING DAMAGE TO AMMUNITION STOWED IN THE FLOOR BINS.
